AEROSTAT ICING PROBLEMS(U) COLD REGIONS RESEARCH AND  
ENGINEERING LAB HANOVER NH 8 HANAMOTO AUG 83  
CRREL-SR-83-23 MIPR-FY71218200015

**Special Report 83-23**

**Aerostat icing problems**

**B. Hanamoto**

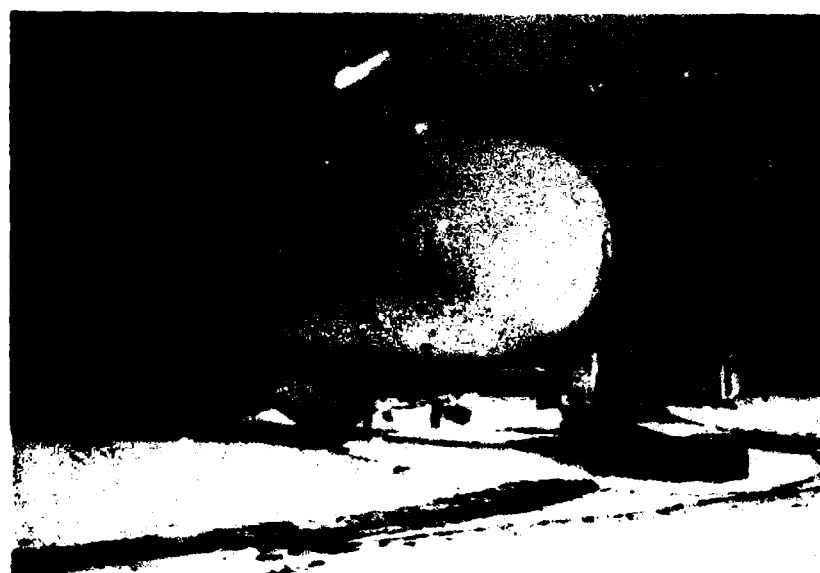
Figure B21. Aerostat system moored to ground platform at Camp Ethan Allen Training Center, Vermont.

Field trials of a prototype 708-m<sup>3</sup> (25,000-ft<sup>3</sup>) balloon were conducted at the Camp Ethan Allen Training Center in northern Vermont during February and March of 1983. During these trials, atmospheric conditions where icing of the balloon would occur were expected. To test the copolymer coating, portions of the balloon were coated in the field on two occasions. The aerostat was moored to its ground platform and the copolymer was roller-applied from a "cherry-picker" type hoist. The surface was not cleaned. Ambient temperatures were -2.2° and 0°C (28° and 32°F) on the two dates. It appeared that a satisfactory coat was put on. The left top quarter from nose to tail and the top surfaces of the fins were coated, as was a section of the vertical fin. The effectiveness of the coating is still to be evaluated.
